**Flood Control Project Maintenance
Levee Inspections**

Maintenance Issue Types Only, Levee Inspection Report By Mile - Fall 2016

Levee District No. 0009 (Sutter County)

Waterway	Bank	Unit Miles	Inspection Start/End	Inspector
Unit No. 01 Sutter County, Feather River	Right	6.25	10/04/2016 10/04/2016	Sterling York

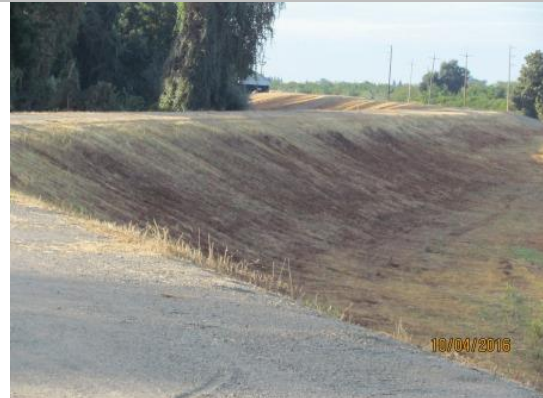
Photo 1 of 2 : FA_2016_LD0009_202_16_20161006_00026.jpg

LM Start	0.01	Rating **	A	Issue No.	16
LM End	6.24	Issue Type +	Ma	Location *	LS
Category	Earthen Levee			GPS Latitude/Longitude	
				Start	End
Item	Vegetation			39.168919 °	39.255752 °
				-121.622539 °	-121.636363 °
DWR ID	DWR_LD0009_01_f_2016_16				
Comment Code					
V1 : Control annual grass and weeds on the levee slopes and easements.					
Inspector Comment					
Well maintained annual vegetation. Fall 2016.

View of well maintained annual vegetation that is mowed on the landside looking downstream. Fall 2016.

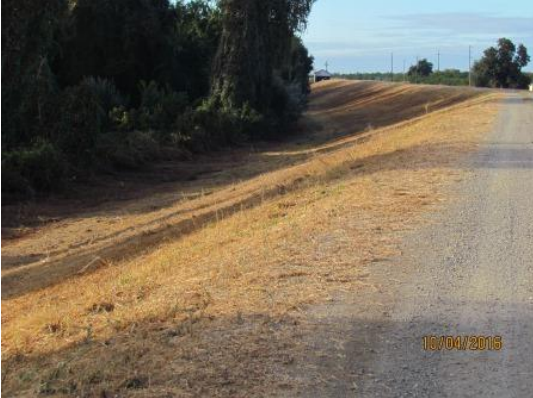
Photo 1 of 2 : FA_2016_LD0009_202_17_20161006_00029.jpg

View of well maintained annual vegetation that is mowed on the waterside looking downstream. Fall 2016.

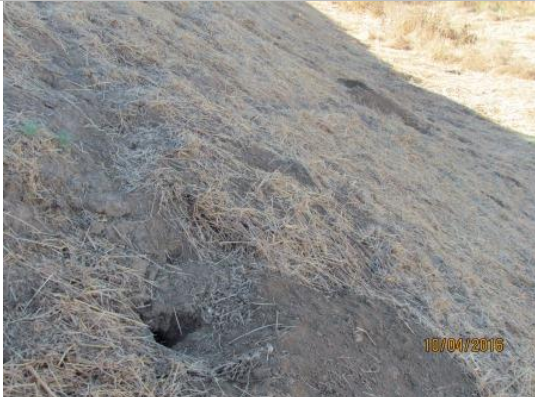
Photo 1 of 1 : FA_2016_LD0009_202_18_20161006_00042.jpg

View of rodent holes that need to be backfilled, no sign of rodents at time of inspection. Fall 2016.

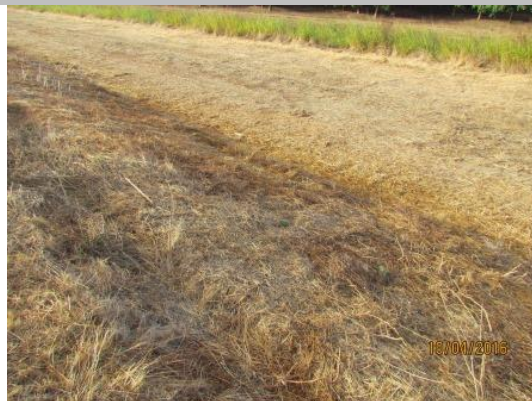
Photo 1 of 1 : FA_2016_LD0009_202_19_20161006_00040.jpg

LM Start	5.32	Rating **	A/W	Issue No.	19
LM End	5.32	Issue Type +	Ma	Location *	CR
Category	Earthen Levee			GPS Latitude/Longitude	
				Start	End
Item	Animal Control			39.242582 °	39.242582 °
				-121.637032 °	-121.637032 °
DWR ID	DWR_LD0009_01_f_2015_19				
Comment Code					
A3 : No rodents visible, but rodent burrows visible; need to backfill and compact or grout burrows.					
Inspector Comment					
This rodent site has been repaired by the LMA and there is no new evidence of rodent activity at this location. The picture was taken during the 2015 Fall Inspection.

View of area on the landside where rodent holes have been repaired.
